**CONTINUING ELIGIBILITY INSPECTION (CEI) REPORT  
FOR HURRICANE & SHORE PROTECTION PROJECTS**

1. Project Name: Aoa Shore Protection Project

2. Date of Inspection: April 9, 2002

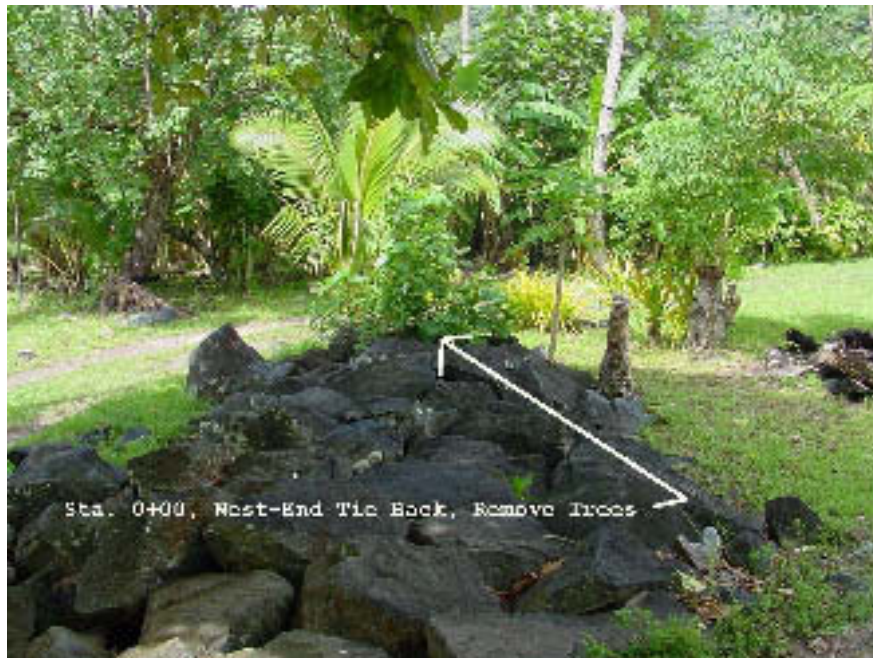
a. Sta. 0+00, End of west tieback, remove trees.

b. Sta. 0+20, Remove tree from front toe of structure.

c. Road built over the revetment (no problem).

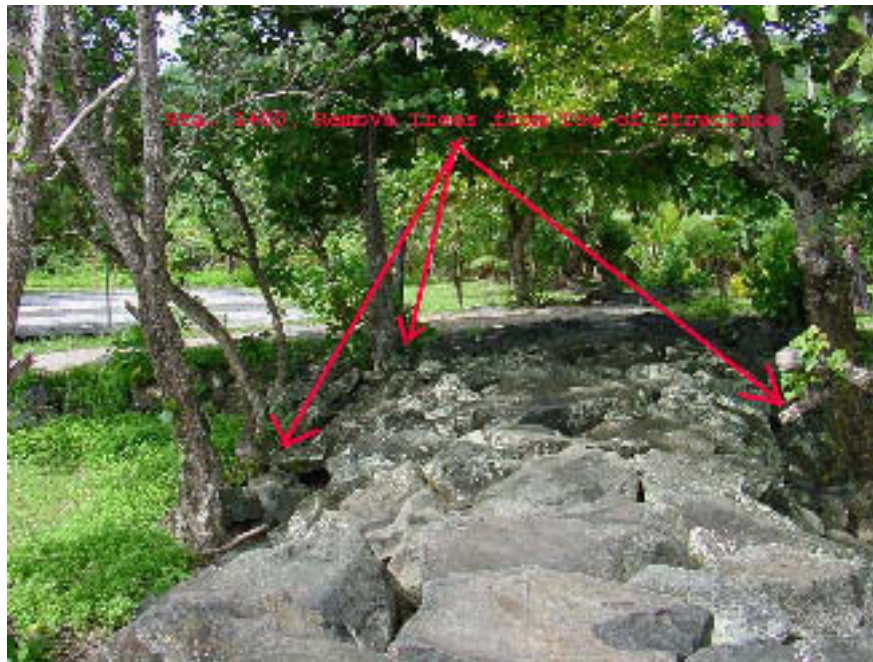
d. Sta. 1+00, Remove vines from structure.

e. Sta. 1+20, 1 split armor stone at the toe.

f. Sta. 1+20, 3 ea. dislodged armor stones at the backside.

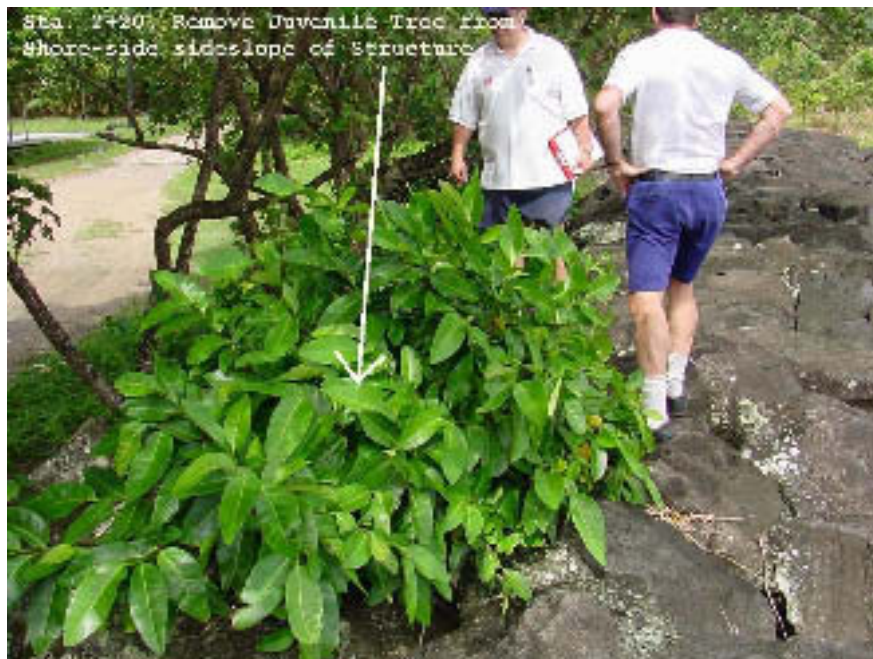
g. Sta. 2+20, Remove juvenile tree from structure.

h. Sta. 3+70, Monitor void / bridging thru structure.

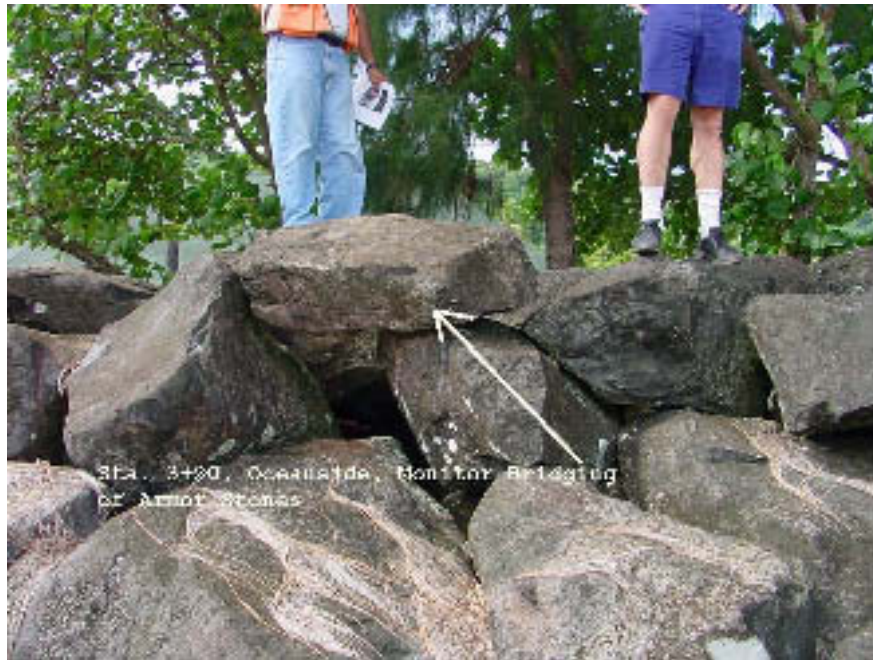
i. Sta. 3+20 - 3+70 Monitor bridging of armor stones, (large tree has been cut on the interior side), slight depression thru crest and down the sideslope.

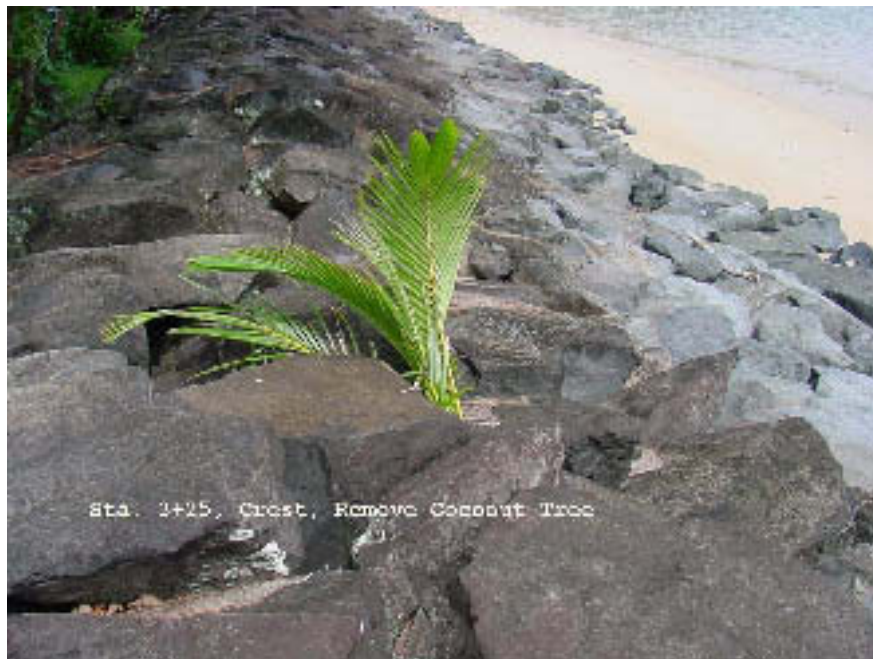
j. Sta. 3+25, Remove coconut tree.

k. Sta. 3+70, Split armor stone, monitor sideslope depression.

l. Sta. 2+70 - 4+70, Monitor sideslope settling.

- m. Sta. 4+70, the big tree has been cut, however continue to monitor dislodged armor stones and monitor bridging and sideslope depression.
- n. Sta. 5+20 - 5+70, 2 split armor stones on the sideslope, monitor bridging.

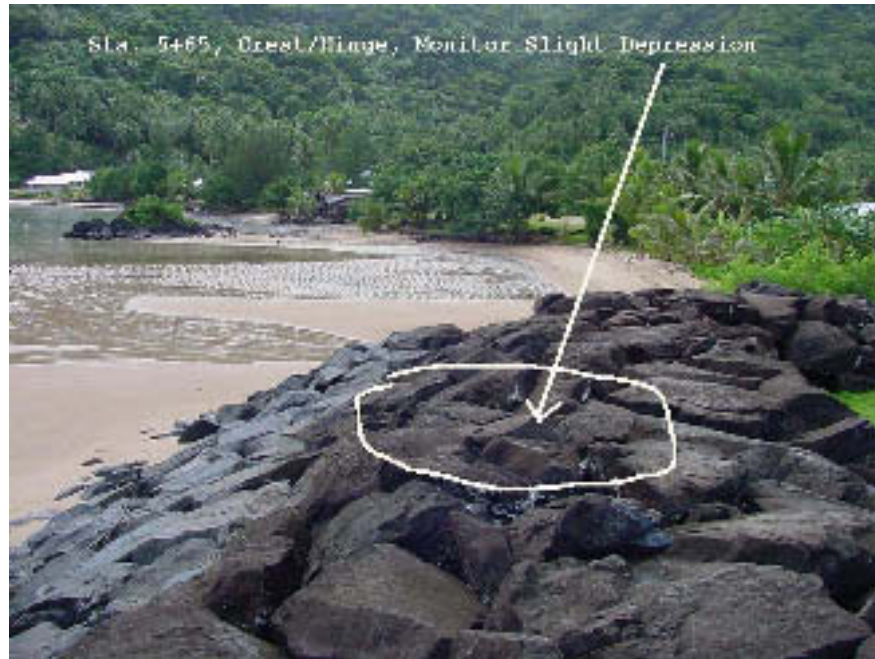
- o. Sta. 5+65, Monitor slight depression at the sideslope / crest hinge.

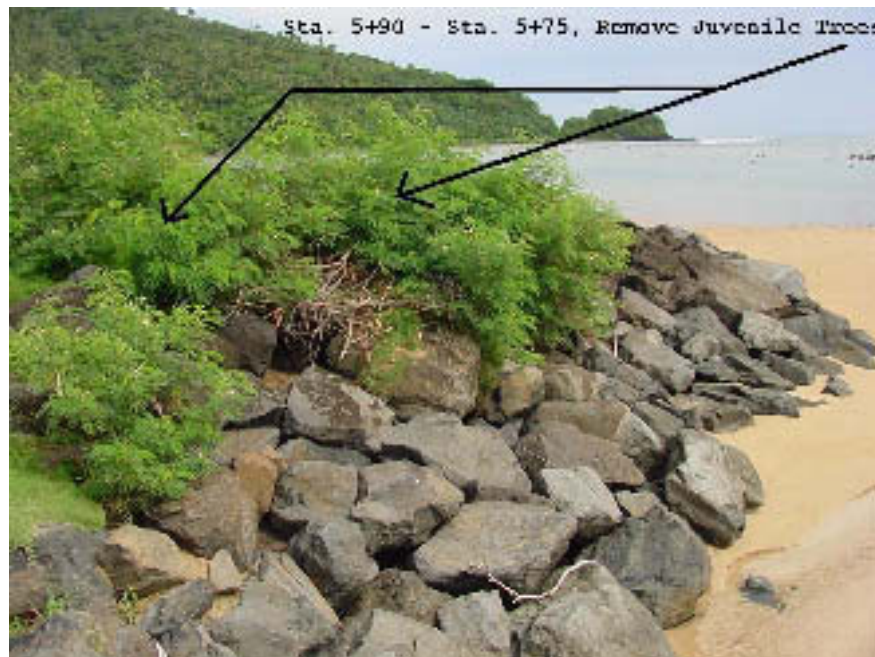
- p. Sta. 5+90, Remove trees and other vegetation from structure.

The focus of the maintenance required should be directed at vegetation control. Removal or herbicides are recommended in lieu of cutting.

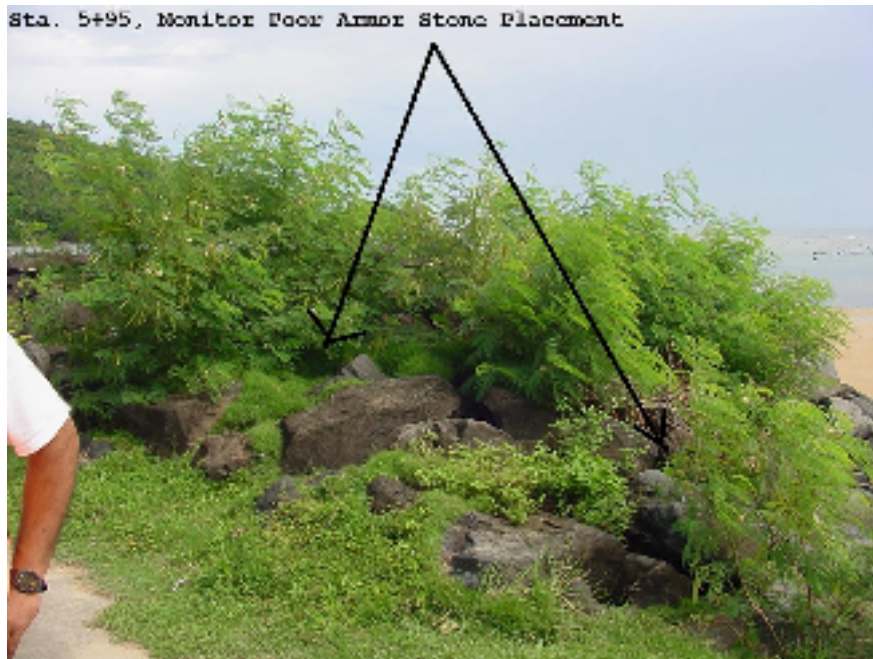
p. Sta. 5+95, Monitor armor stone. Stone is in place (or the existing armor stone has been repositioned) but not keyed or fitted. Loss of contact and bridging at the tie-in to the culvert wing wall. Loose stones at the toe (results of construction of the 13' x 5' box culvert in the adjacent stream).
